Name Of Dam: TOMS CREEK DAM
Location: WISE COUNTY, VIRGINIA
Inventory Number: VA. NO. 19510

PHASE I INSPECTION REPORT

NATIONAL DAM SAFETY PROGRAM

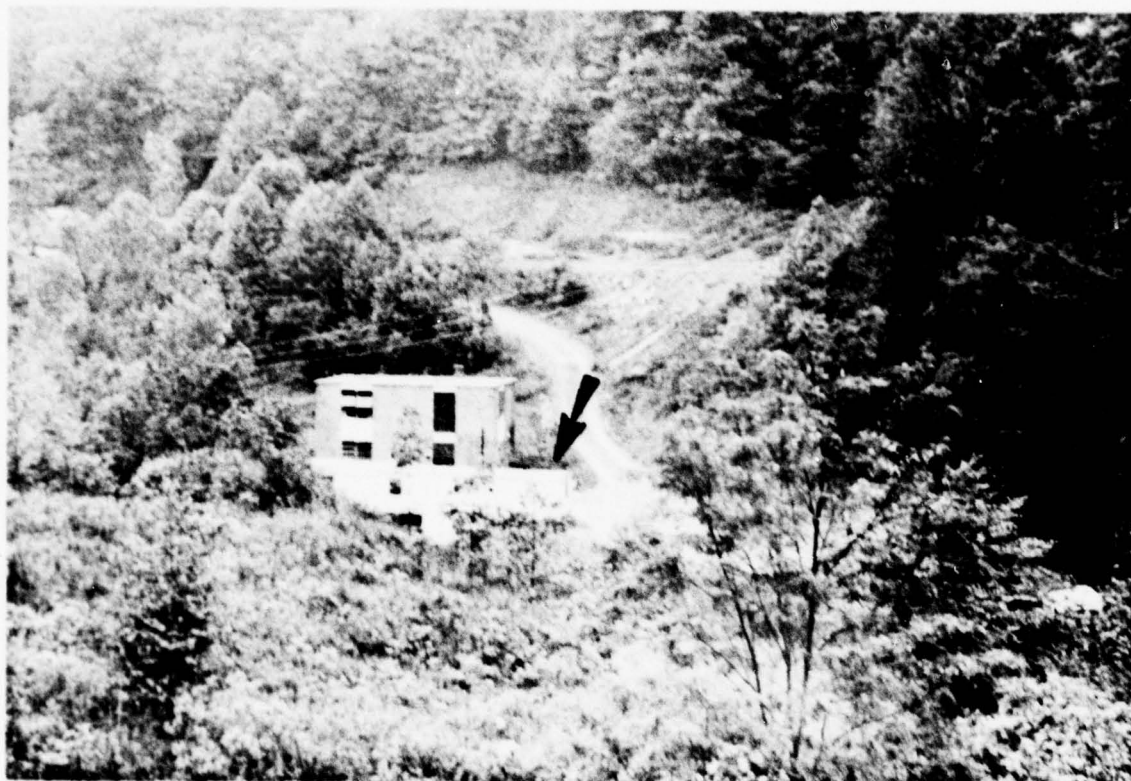
1.2.4 Hazard Classification: The dam is located in a rural area; however, based upon the location of a home and water filtration plant approximately 300 ft downstream (See Photo 1, Appendix II), and the industrial development and several homes within 2 miles downstream of the dam, the dam is assigned a "significant" hazard classification. The hazard classification used to categorize a dam is a function of location only and has nothing to do with its stability or probability of failure.

WATER TREATMENT PLANT DOWNSTREAM
(NOTE CARETAKER'S HOME, ARROW)

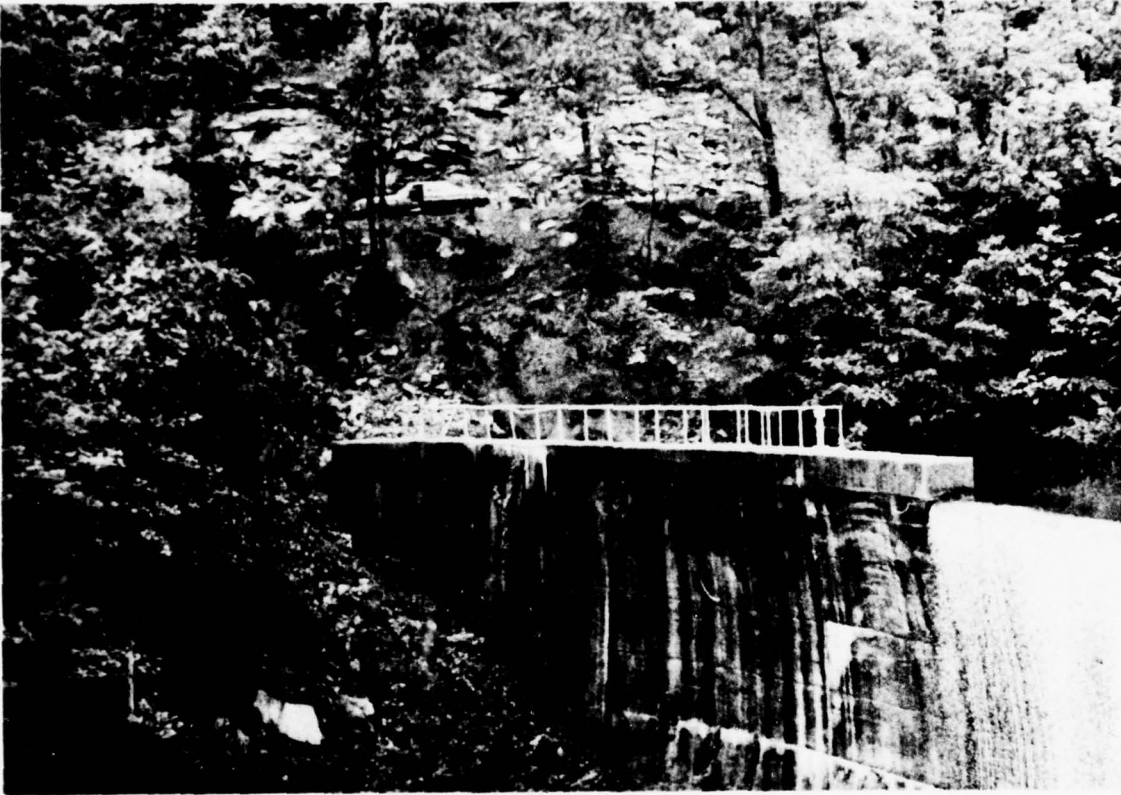
VIEW OF RIGHT ABUTMENT WHERE BOLDER
WASHED OFF ROAD ONTO WALKWAY (NOTE
BENT HANDRAIL)

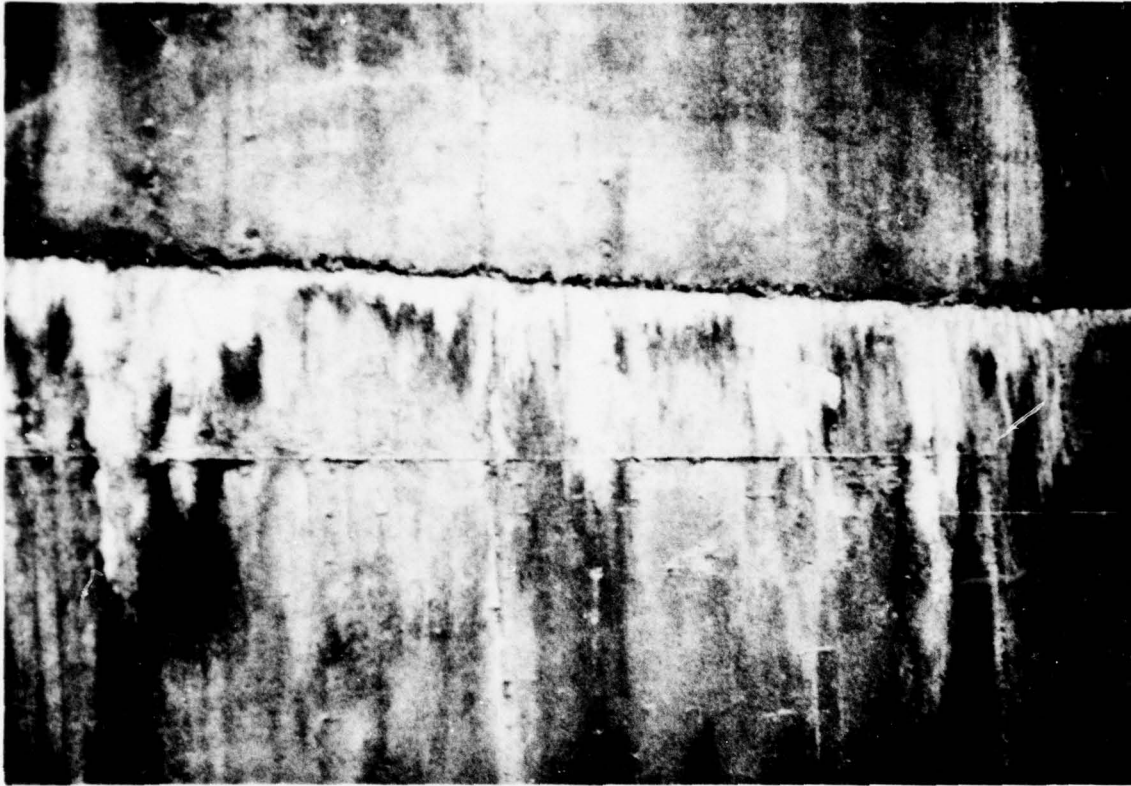
VIEW OF COLD JOINT

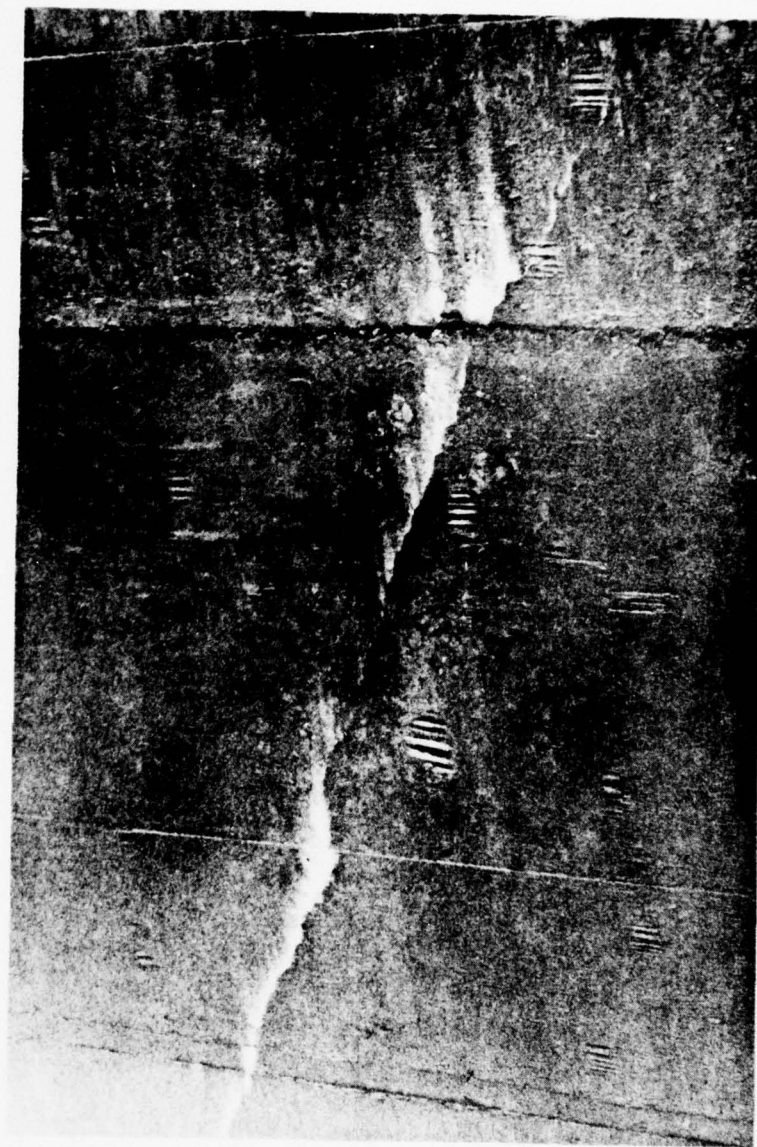
CRACK IN SURFACE

1.6 Surface Cracks, Concrete Surfaces: Minor cracks were observed on left abutment. Only one thin crack, approximately 10 ft long and at a 60 degree angle across the left downstream face, was encountered. It is patched and is located near the left abutment.

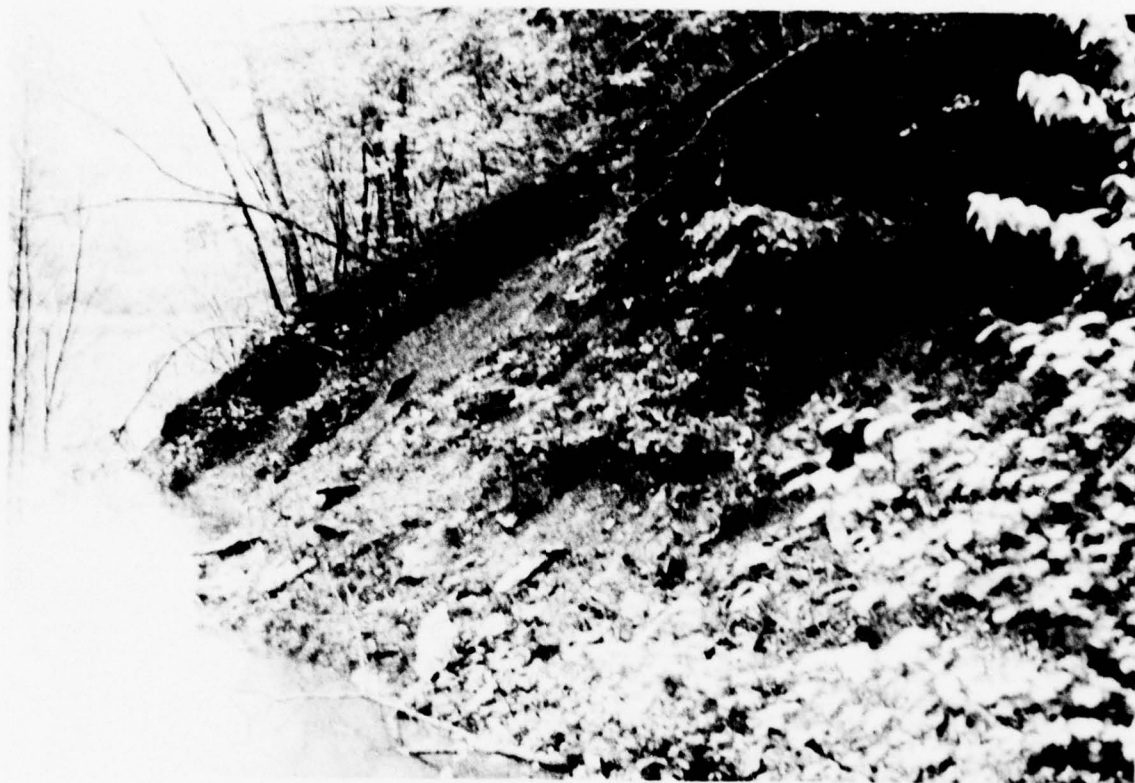
SLOUGHING ABOVE LEFT ABUTMENT
